DNA-TR-90-72-V3

**Exposure of Air Breathing Engines to Nuclear Dust  
Environment (U)  
Volume III—Performance Deterioration of a Second F100  
Turbofan Engine Upon Exposure to a Simulated Nuclear  
Dust Environment (U)**

Michael G. Dunn  
Calspan Corporation  
P.O. Box 400  
Buffalo, NY 14225

January 1991

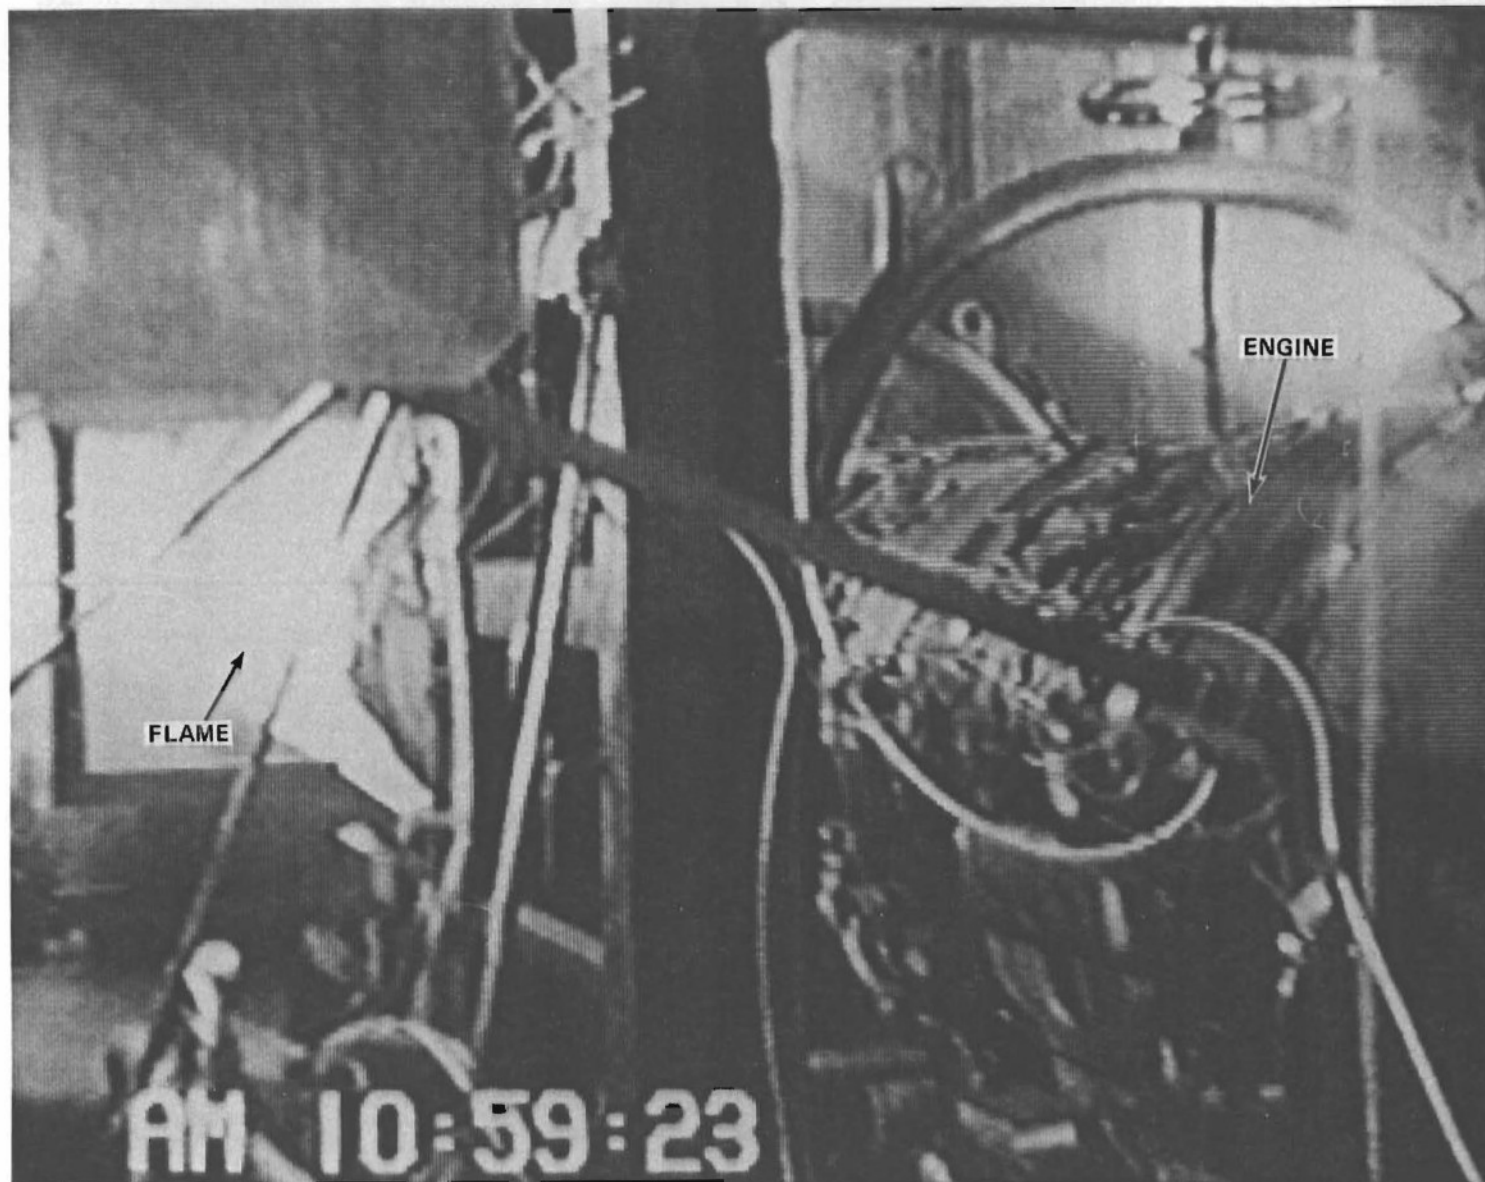
Figure 14. (U) Side view photograph of engine during surge event.

[REDACTED] Figure 14 is a side-view photograph of the engine taken during the surge event. The viewer gets a good view of the extent of the flame in the tailpipe region from this photograph. The entire backwall of the test cell is illuminated by the flame. Figure 15(a) is a front view photograph taken prior to the start of the throttle excursion at a time of 10:56:26. Therefore, this photograph was taken a little less than three minutes prior to the event that resulted in violent surging of the engine. The St. Elmo's glow at the fan face is clearly visible. The glow is the result of a static discharge caused by the dust particles flowing into the engine being struck by the rotating fan blades. The dark region in the center of the photograph is the nose cover which is stationary. Figure 15(b) is a photograph taken with the same camera at a time of 10:59:19 which was during throttle excursion. This photograph was taken immediately before a surge. Note that the St. Elmo's glow has disappeared, suggesting that axial flow of air through the machine has stopped. Figure 16 is a photograph taken during the surge event. The time on the photograph is also 10:59:19 but as noted earlier, the camera records sixty frames/sec and the clock only updates on a one-second basis. The photograph illustrates a bright ring of light around the fan perimeter which is a view of the fire propagating forward. To confirm that the fire did propagate forward, after the engine was shut down a very bright light was placed at the exit of the low-pressure turbine. No light could be seen at the fan face.

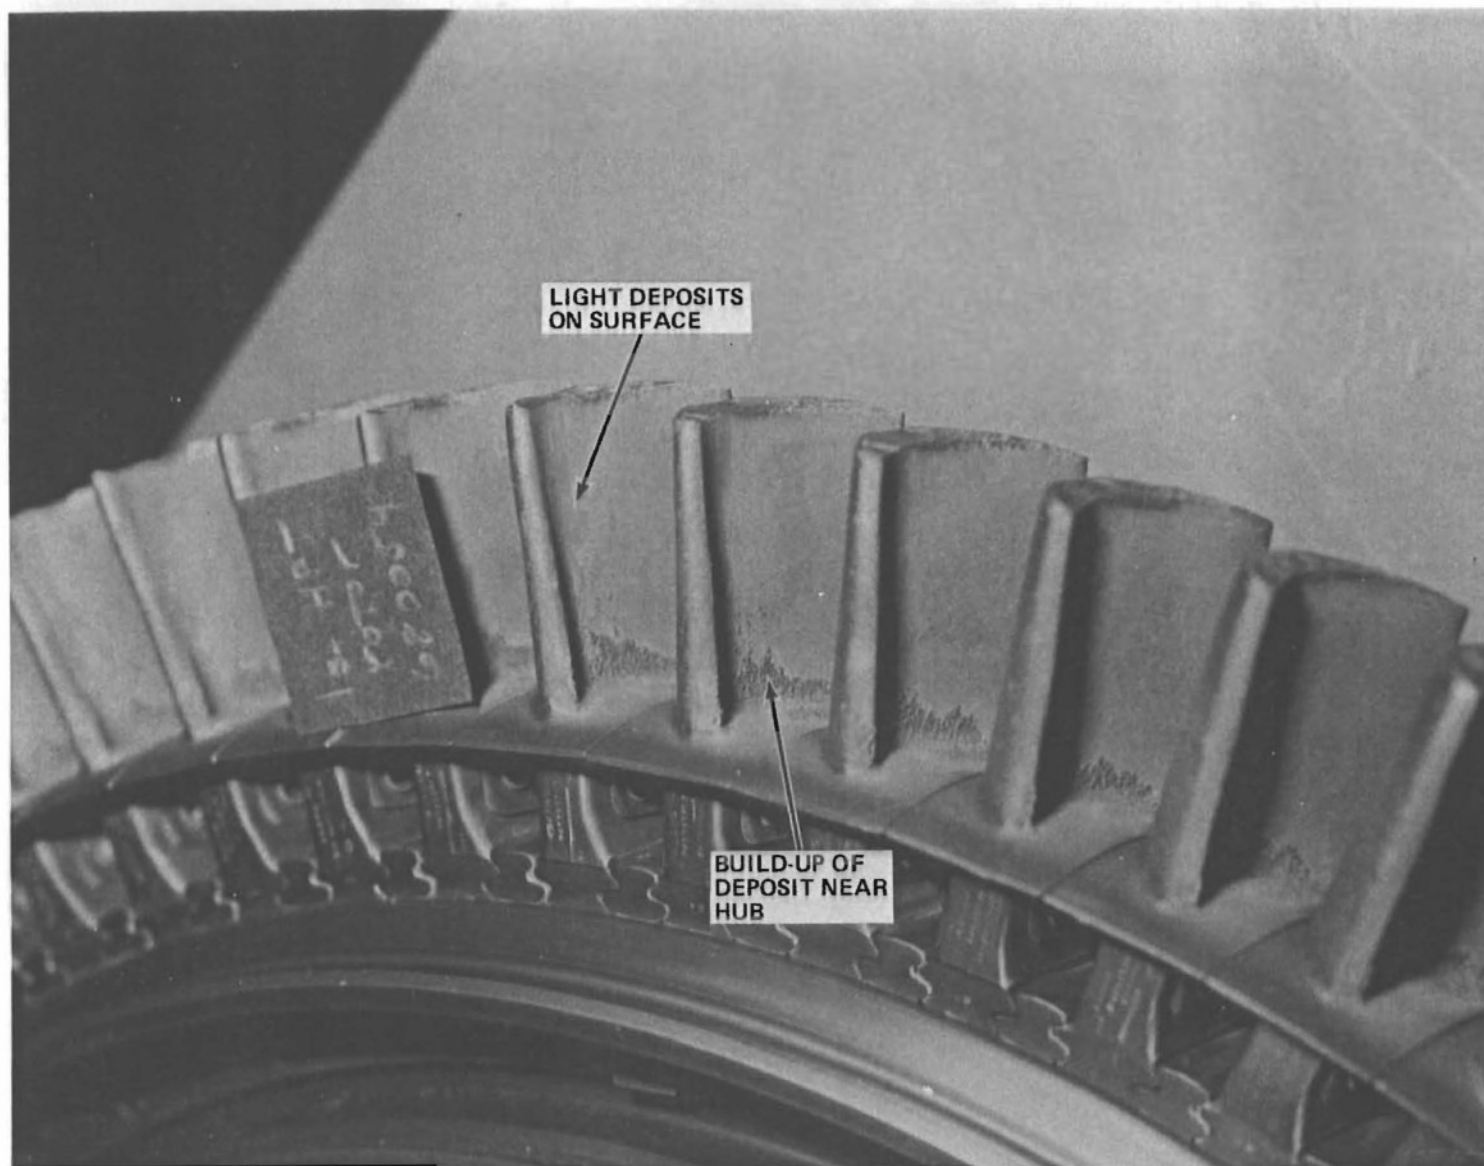
Figure 19. (U) Photograph of first-stage high-pressure turbine rotor.

Figure 19 is a photograph of the first-stage high-pressure turbine rotor. There was a light deposit of material on the pressure surface and a little heavier deposit on the pressure surface near the hub. However, this material was not of a glassy nature and could be removed with relative ease.

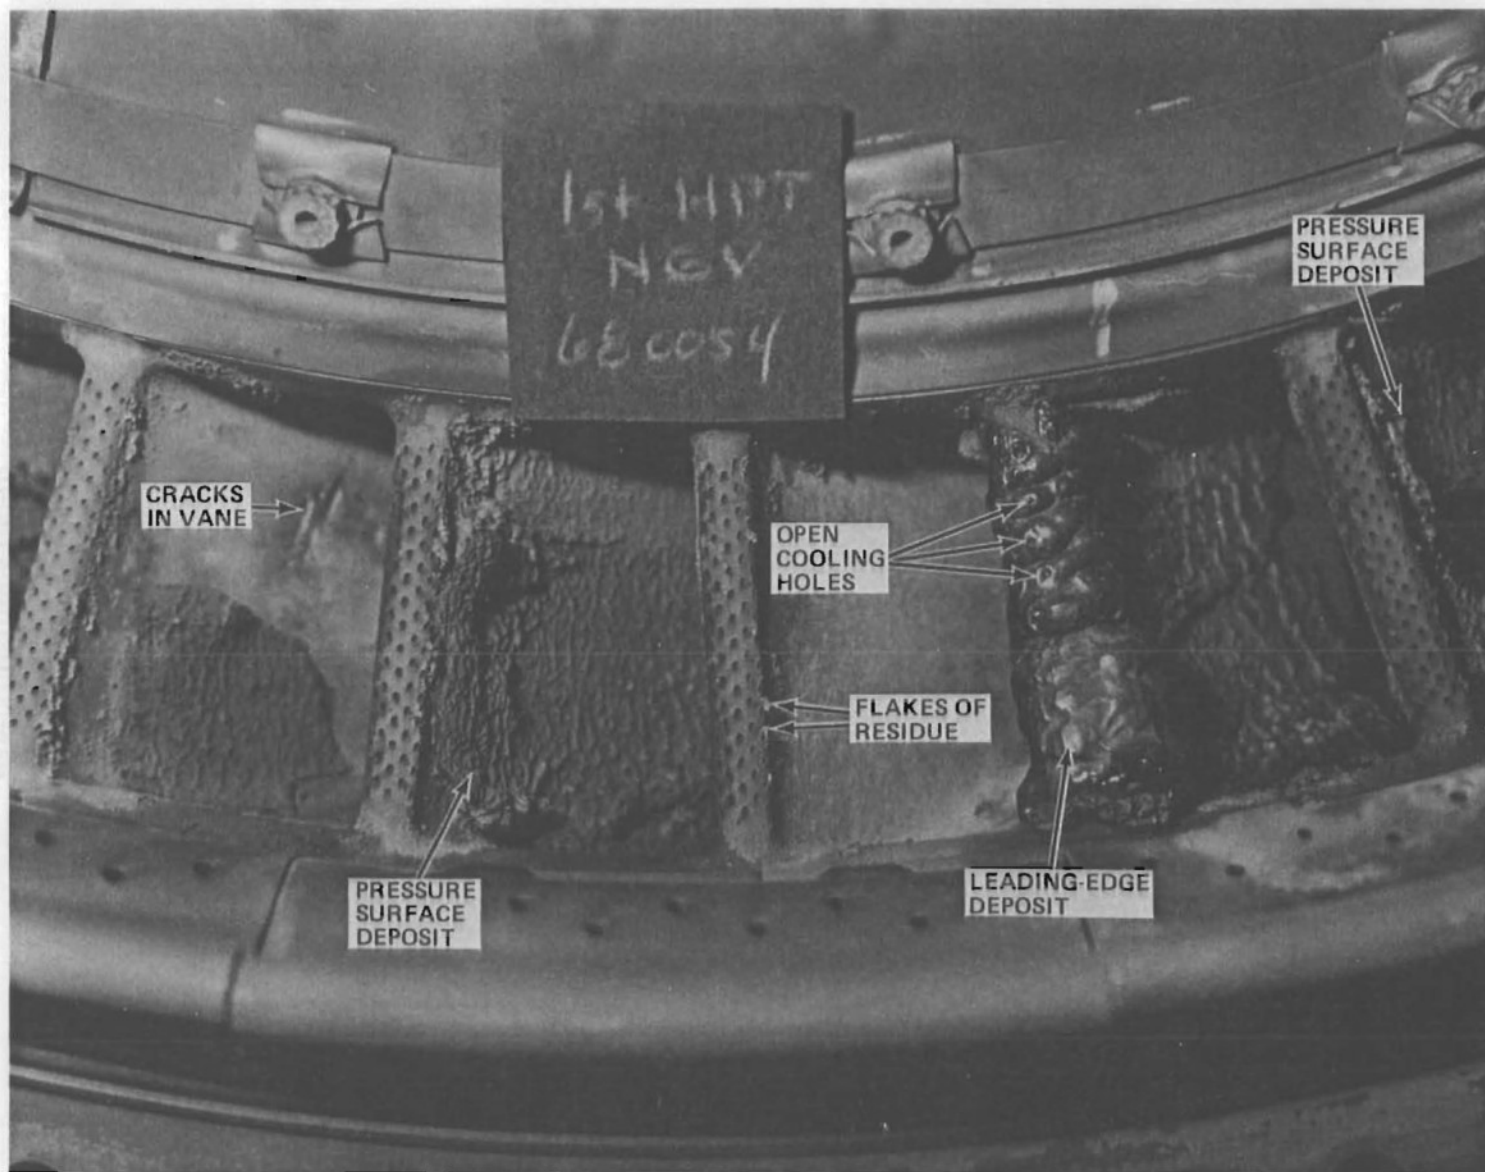
Figure 20. (U) Photograph of nozzle guide vane for first stage high-pressure turbine.

Figures 20, 21 and 22 are photographs taken of different portions of the high-pressure turbine first stage nozzle guide vane. Figure 20 illustrates the large deposit completely covering the vane leading edge. The cooling holes near the inner hub appear to still be open. However, beyond midspan the holes are blocked. Very heavy deposits on the vane pressure surface can be seen on two of the vanes shown in this photograph. One of the vanes is free of deposits, but the flakes remaining on the

The heavy deposits on the nozzle guide vane of the first stage of the high-pressure turbine are felt to have caused the rapidly increasing burner pressure and compressor discharge pressure that were illustrated in Section 3.4. These deposits caused excessive blockage at the NGV causing the operating line to move dangerously close to the surge line. In attempting to clear the deposits on the third purge attempt, the capability of the machine to operate normally was exceeded and the uncontrollable surge described in Section 3.5 resulted.

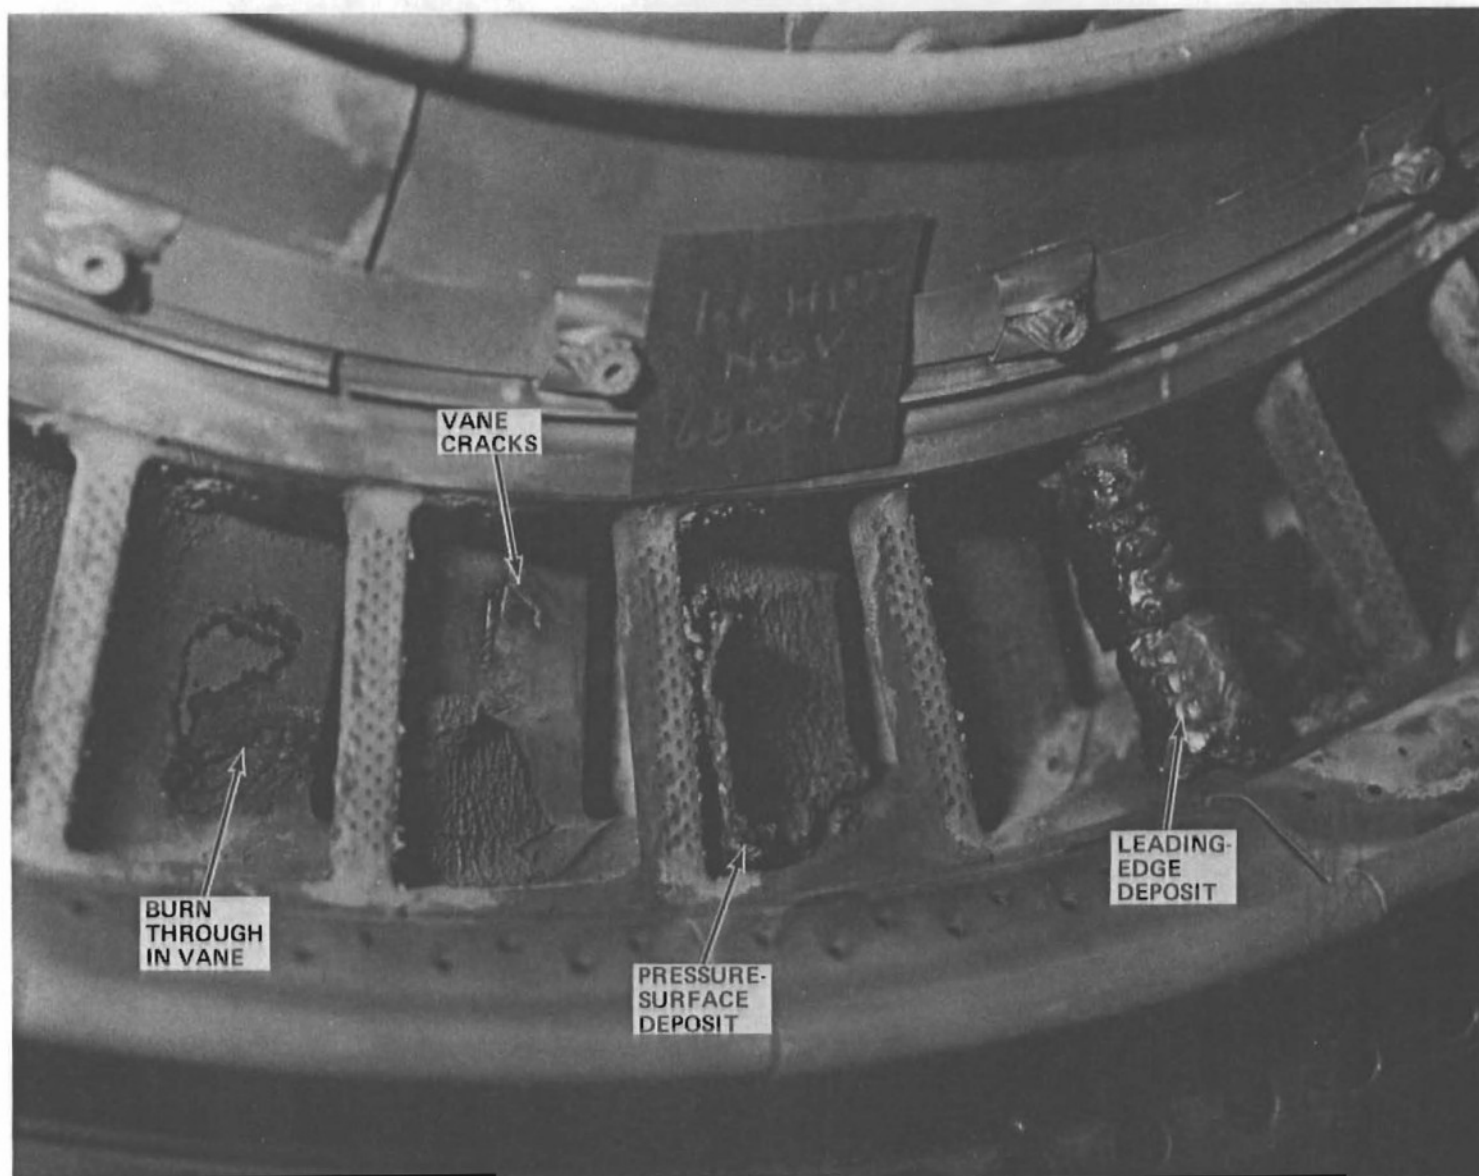
Figure 21. (U) Photograph of nozzle guide vane for first stage high-pressure turbine.

Figure 21 is a photograph of a different portion of the nozzle guide vane of the first stage high-pressure turbine. The vane to the far left has been burned through the pressure surface to the suction surface. The vane next to this one had some large cracks, but didn't appear to burn through. The vane in the center has a large deposit on the pressure surface, but the leading-edge deposit has blown away. Note that the deposit does not adhere well to the vane surface after the component cools and that this is consistent with the result reported in Reference 2. The vane on the right side of Figure 21 has a heavy deposit on the leading edge and on the pressure surface. This is the same deposit shown in the close-up view of Figure 20 and was described in conjunction with that photograph. Figure 22 is a close-up photograph of another of the leading-edge deposits on the vane. It appears that this deposit has blocked all of the cooling holes. The deposit further along the pressure surface of this vane has blown away.

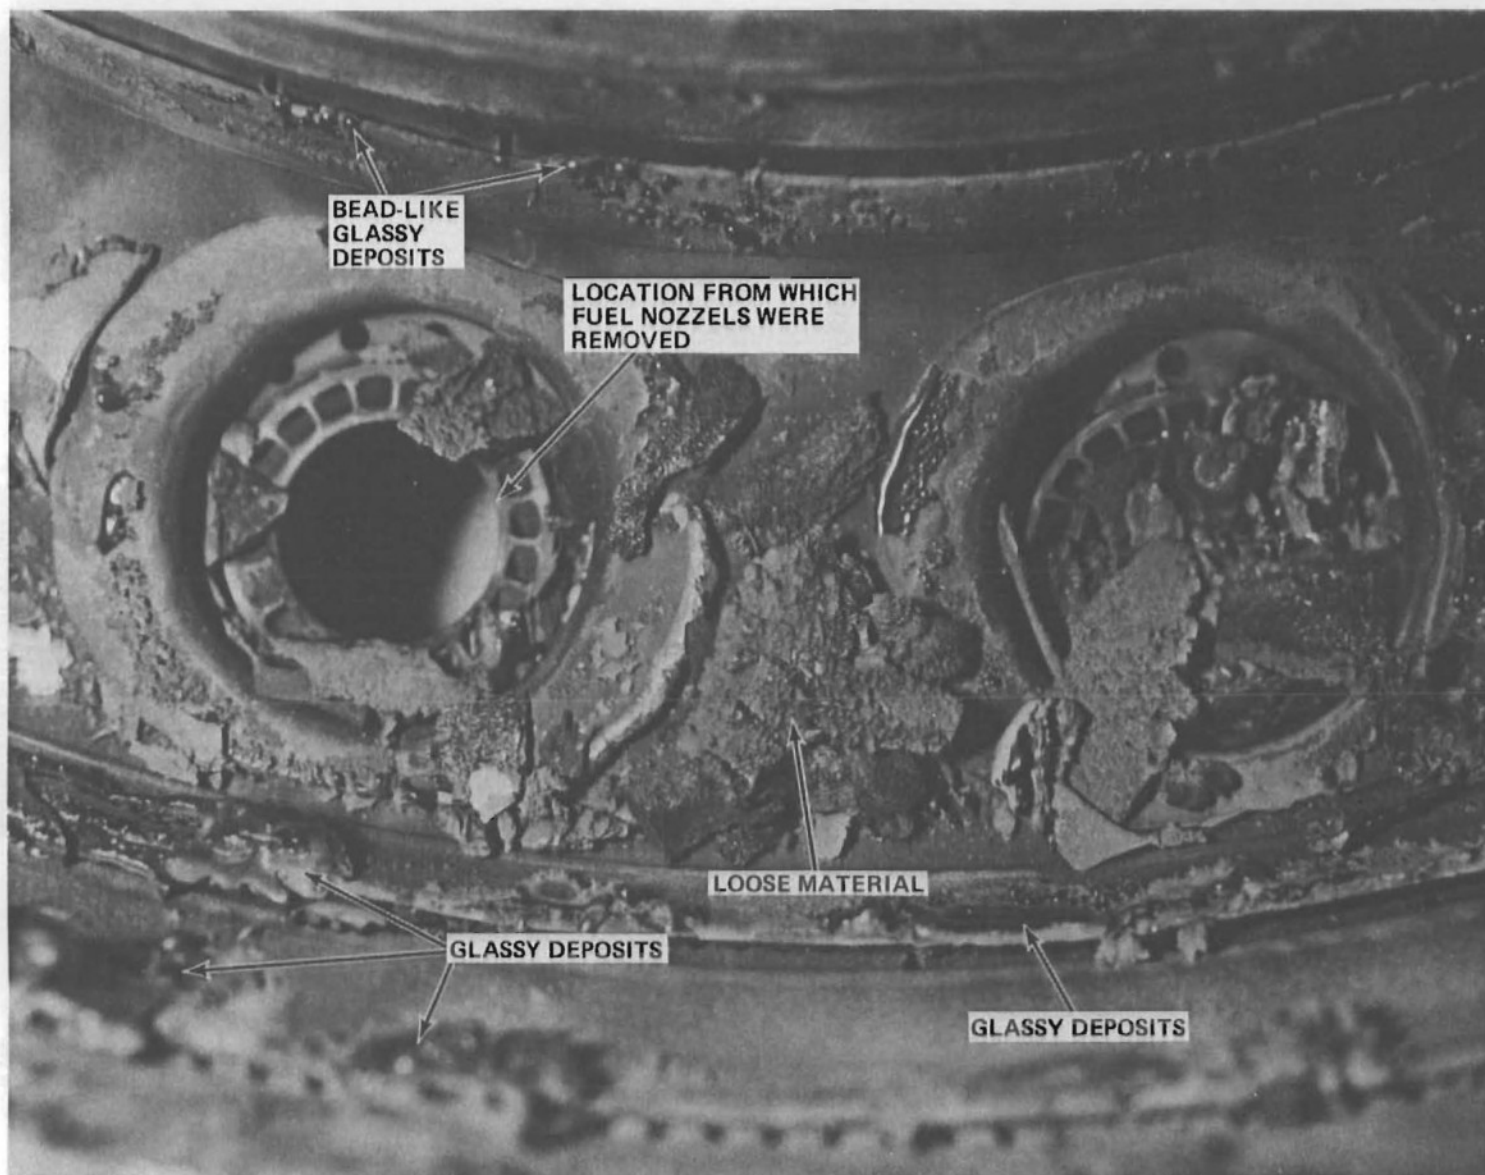
Figure 23. (U) Photograph of combustor liner.

Figure 23 is a photograph taken looking down into the combustor liner. It was difficult to get a photograph of the inside of this liner, but visually one could see many glassy deposits attached to the liner. At the bottom of the liner near the location where the fuel nozzles are located, many bead-like glassy deposits could be seen. Looking down into the liner, a lot of black sooty-like material could be seen also attached to the liner sidewall. The material shown lying in the bottom of the liner was loose and fell out as soon as the liner was tipped on end.

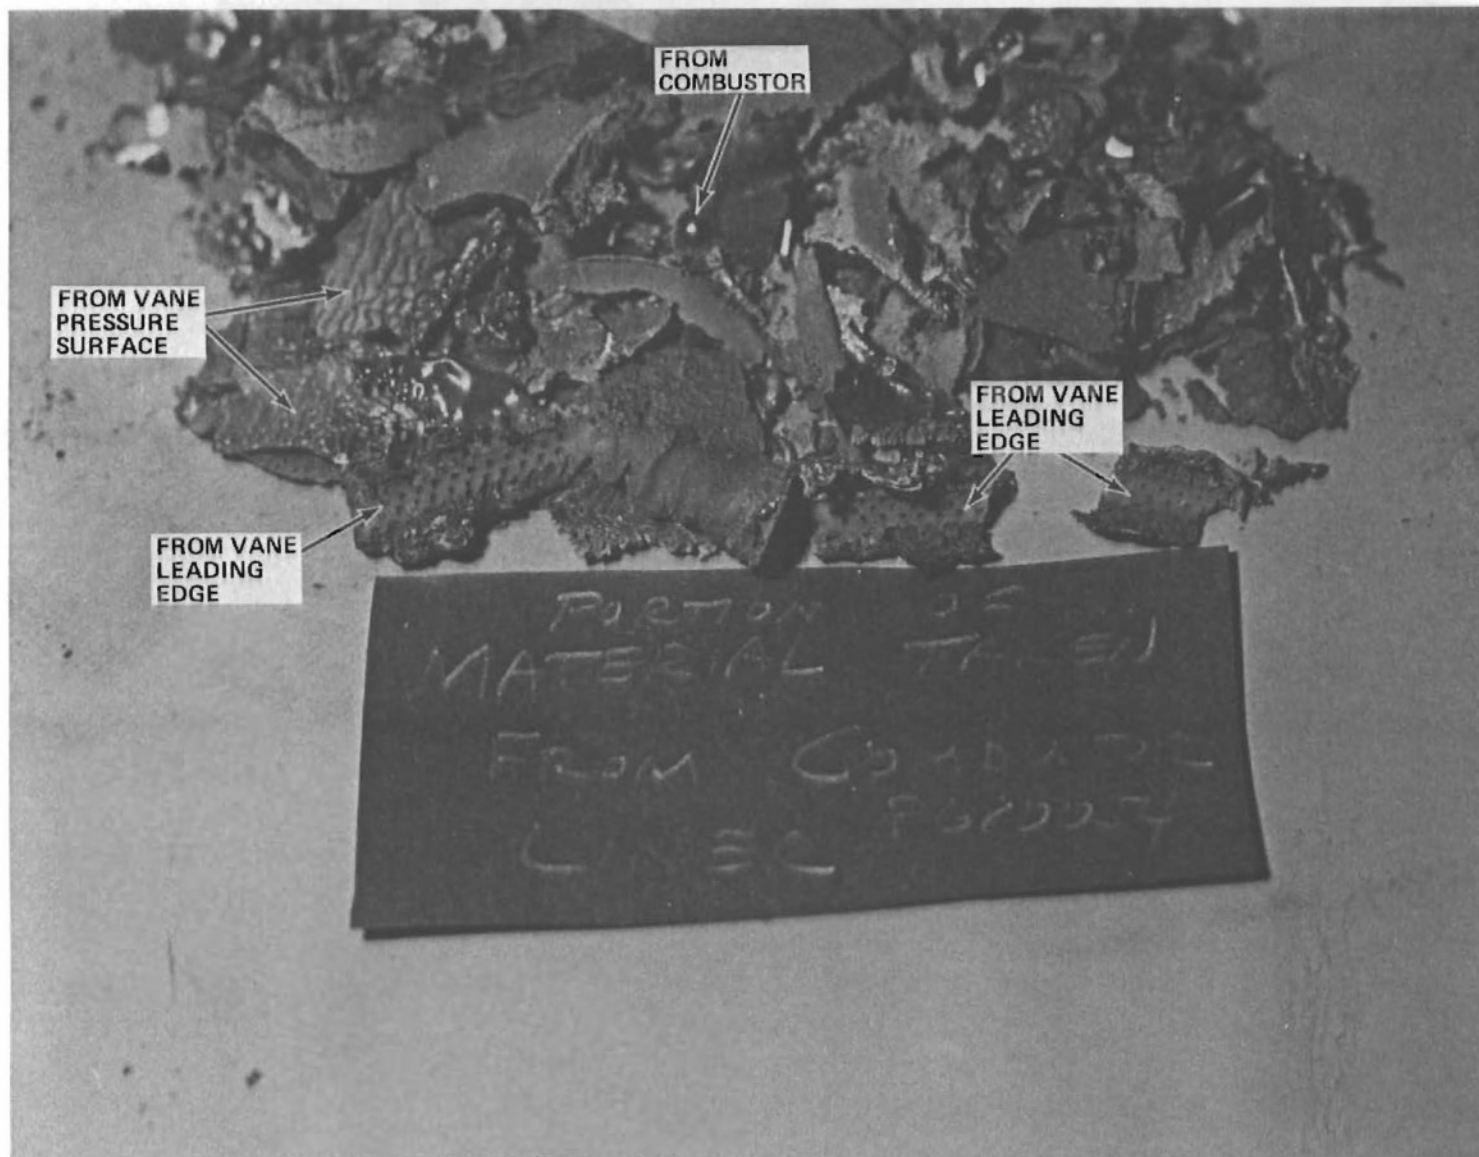
Figure 24. (U) Photograph of material that fell out of combustor liner.

Figure 24 is a photograph of a portion of this loose material that fell out of the combustor liner at disassembly. Many of the pieces shown in this photograph can be identified as having come from the vane leading edge, the vane pressure surface, and the combustor liner wall. Figure 25 is a close-up photograph of several of these pieces that came from the vane leading edge. When these pieces were held up to the

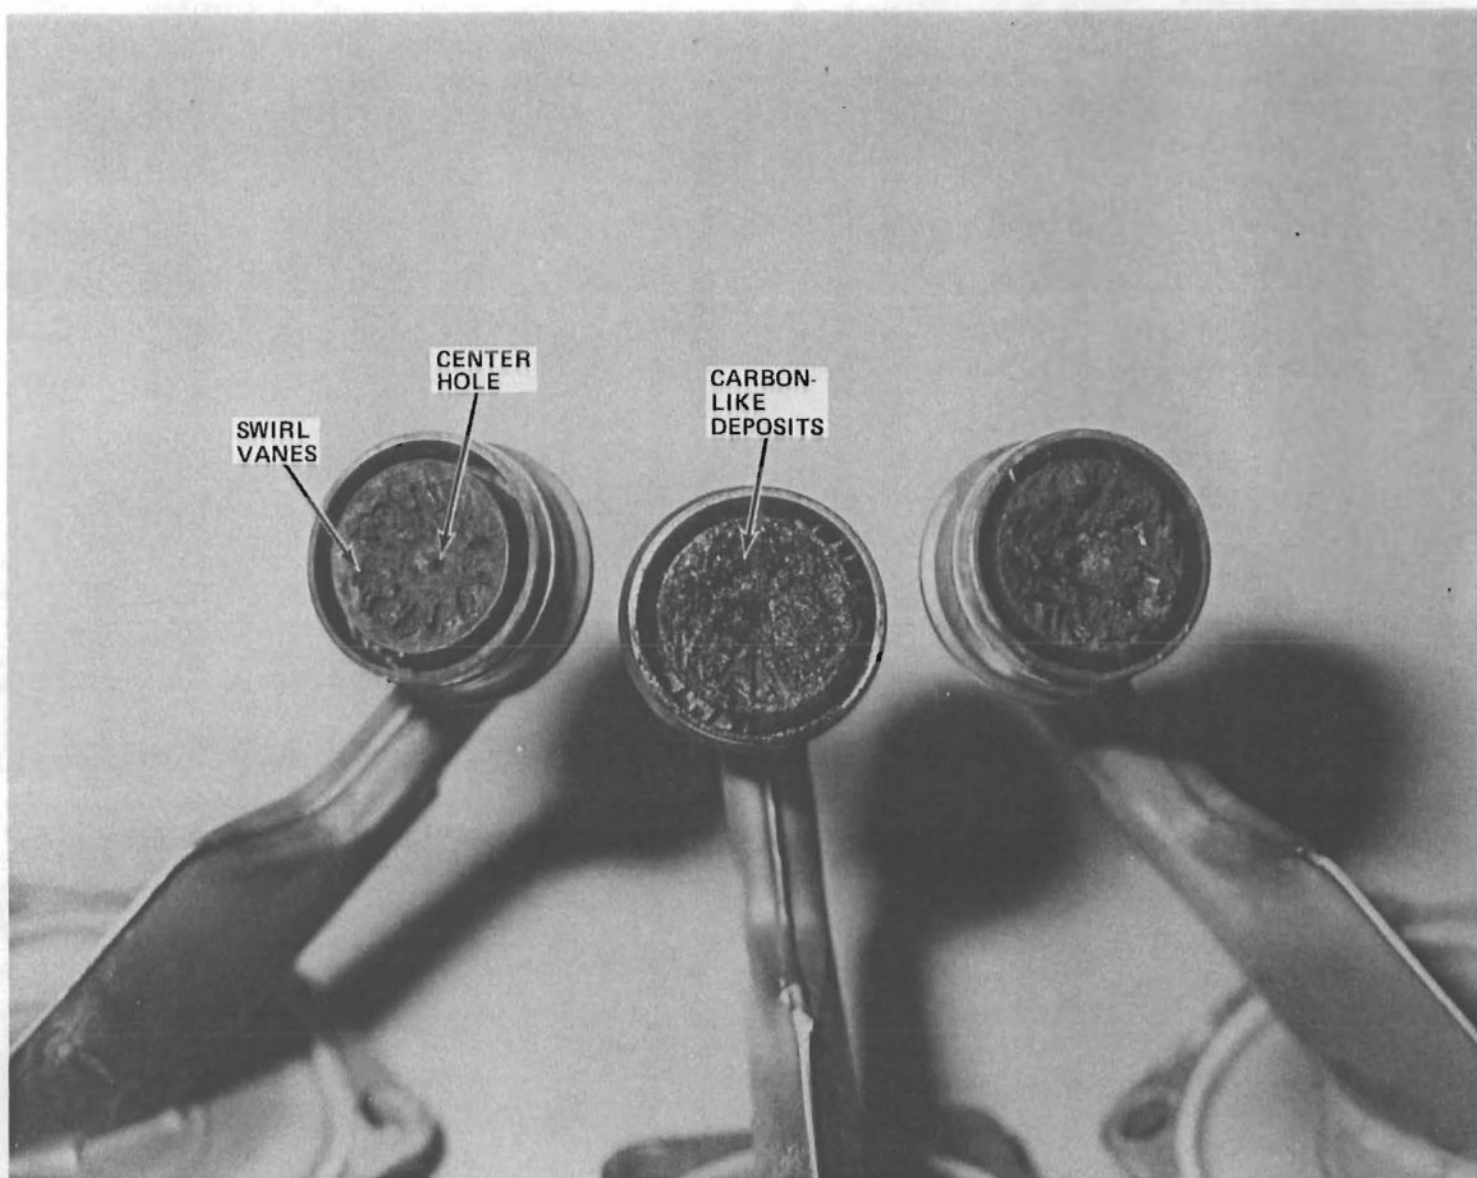
Figure 26. (U) Close-up photograph of fuel nozzles.

Figure 26 is a close-up photograph of three of the fuel nozzles taken out of the combustor. The center hole of the nozzle is open so that fuel could be sprayed into the combustor, but the swirl vanes are badly blocked. Without air passing through these swirl vanes, fuel atomization in the combustor would not be as good as it should be. The condition of the fuel nozzles is felt to be a significant contributor to the reason why we could not start the engine after the surge event described in Section 3.5

- 3) The operator should become very familiar with the operation of the engine control system for his particular engine. As damage to the components becomes more extensive, the control system takes over and attempts to protect the engine. If the operator doesn't recognize the dusty environment, or if he is unfamiliar with the control system operation, or if he doesn't know which of the engine parameters to monitor, then the result can be an engine shut down. If the fuel nozzles have not been damaged by deposition of the carbon-like material shown herein, then it will probably be possible to restart the engine after the hot section components cool and the deposited material breaks up. For both cases in which the fuel nozzles were carbonized in our experiments, it was not possible to restart the engine.

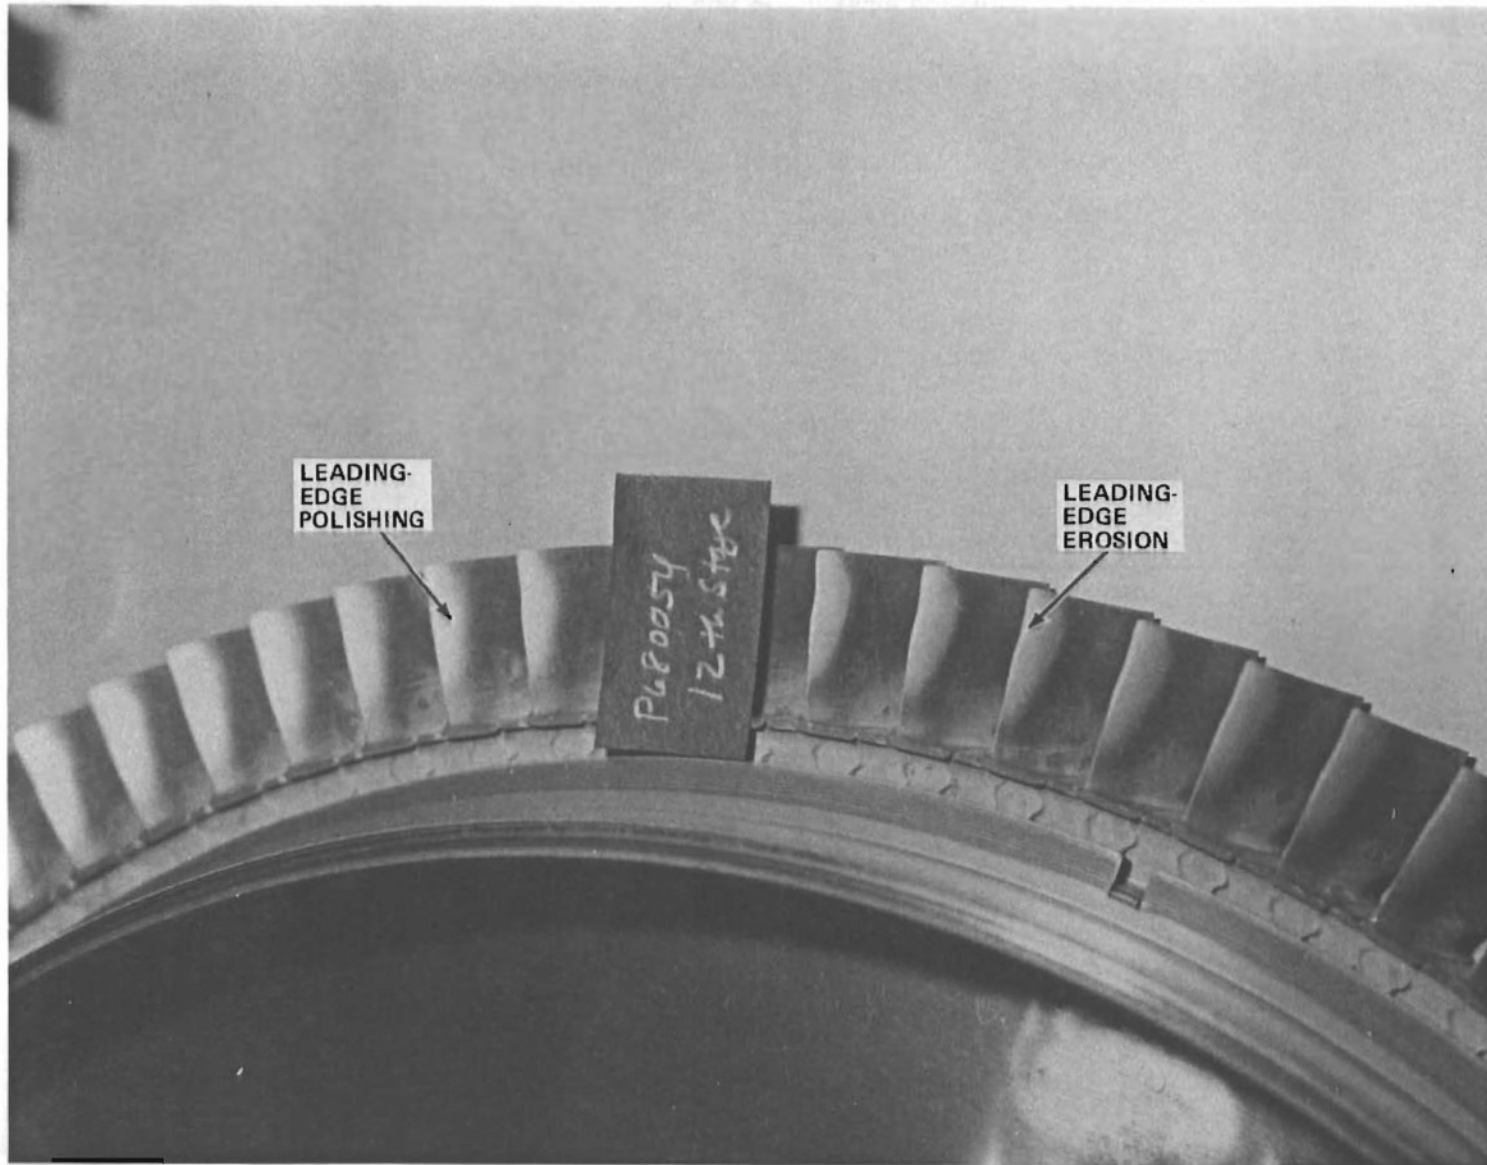
Figure 29. (U) Photograph of 12th stage compressor rotor.

Figure 29 is a photograph of the 12th stage compressor rotor. This stage looks very similar to the stage shown in Figure 27. There is no discoloration of the blades as was observed with the previous engine (see Reference 1). A close look at the tip region of this rotor indicates that tip erosion is very small. Once again, the increase in tip clearance is primarily due to erosion of the abradable seal and not the blade tip.

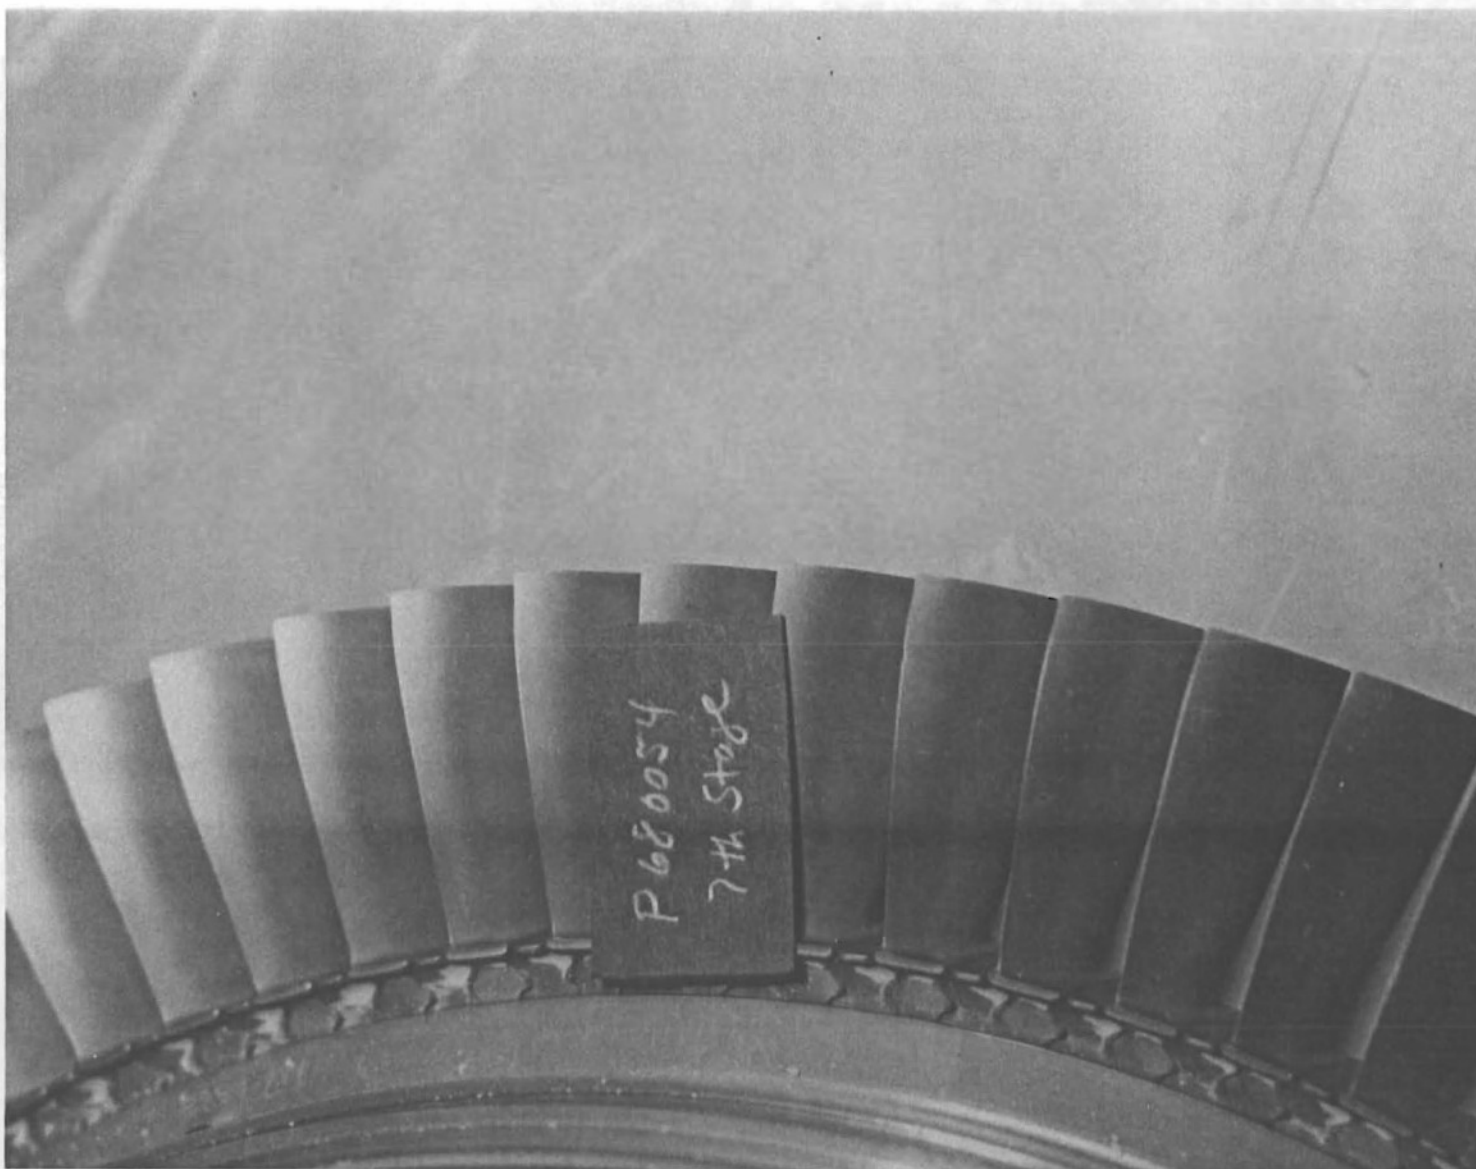
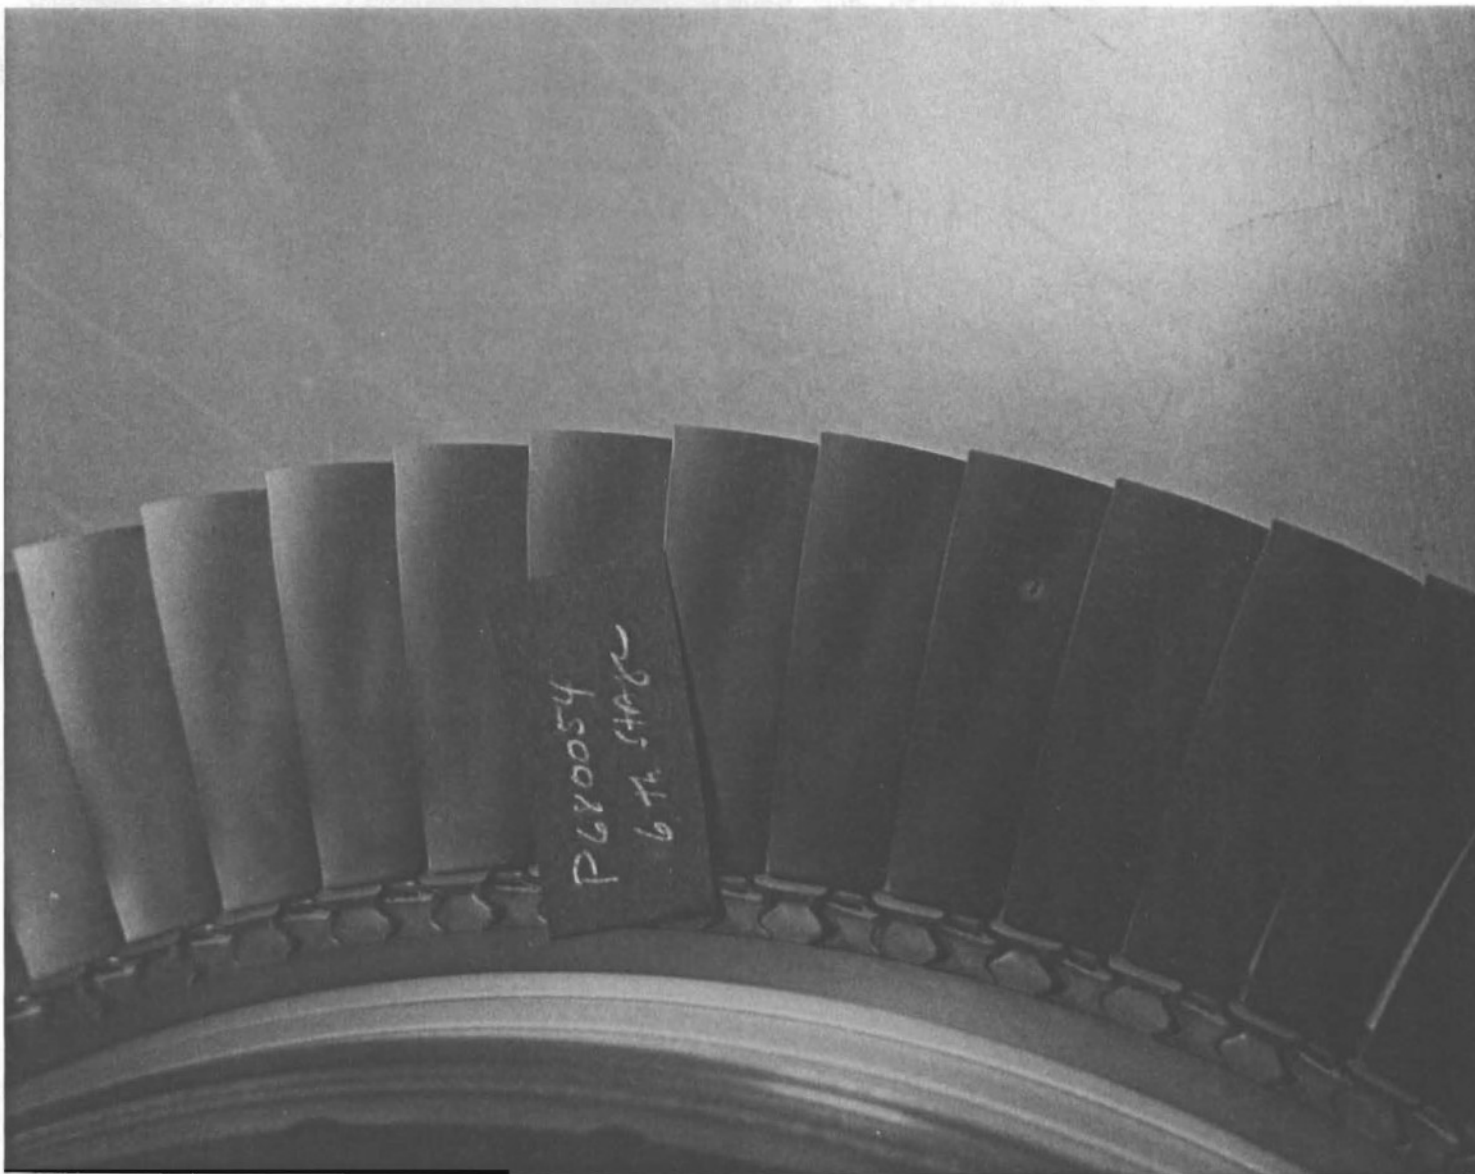
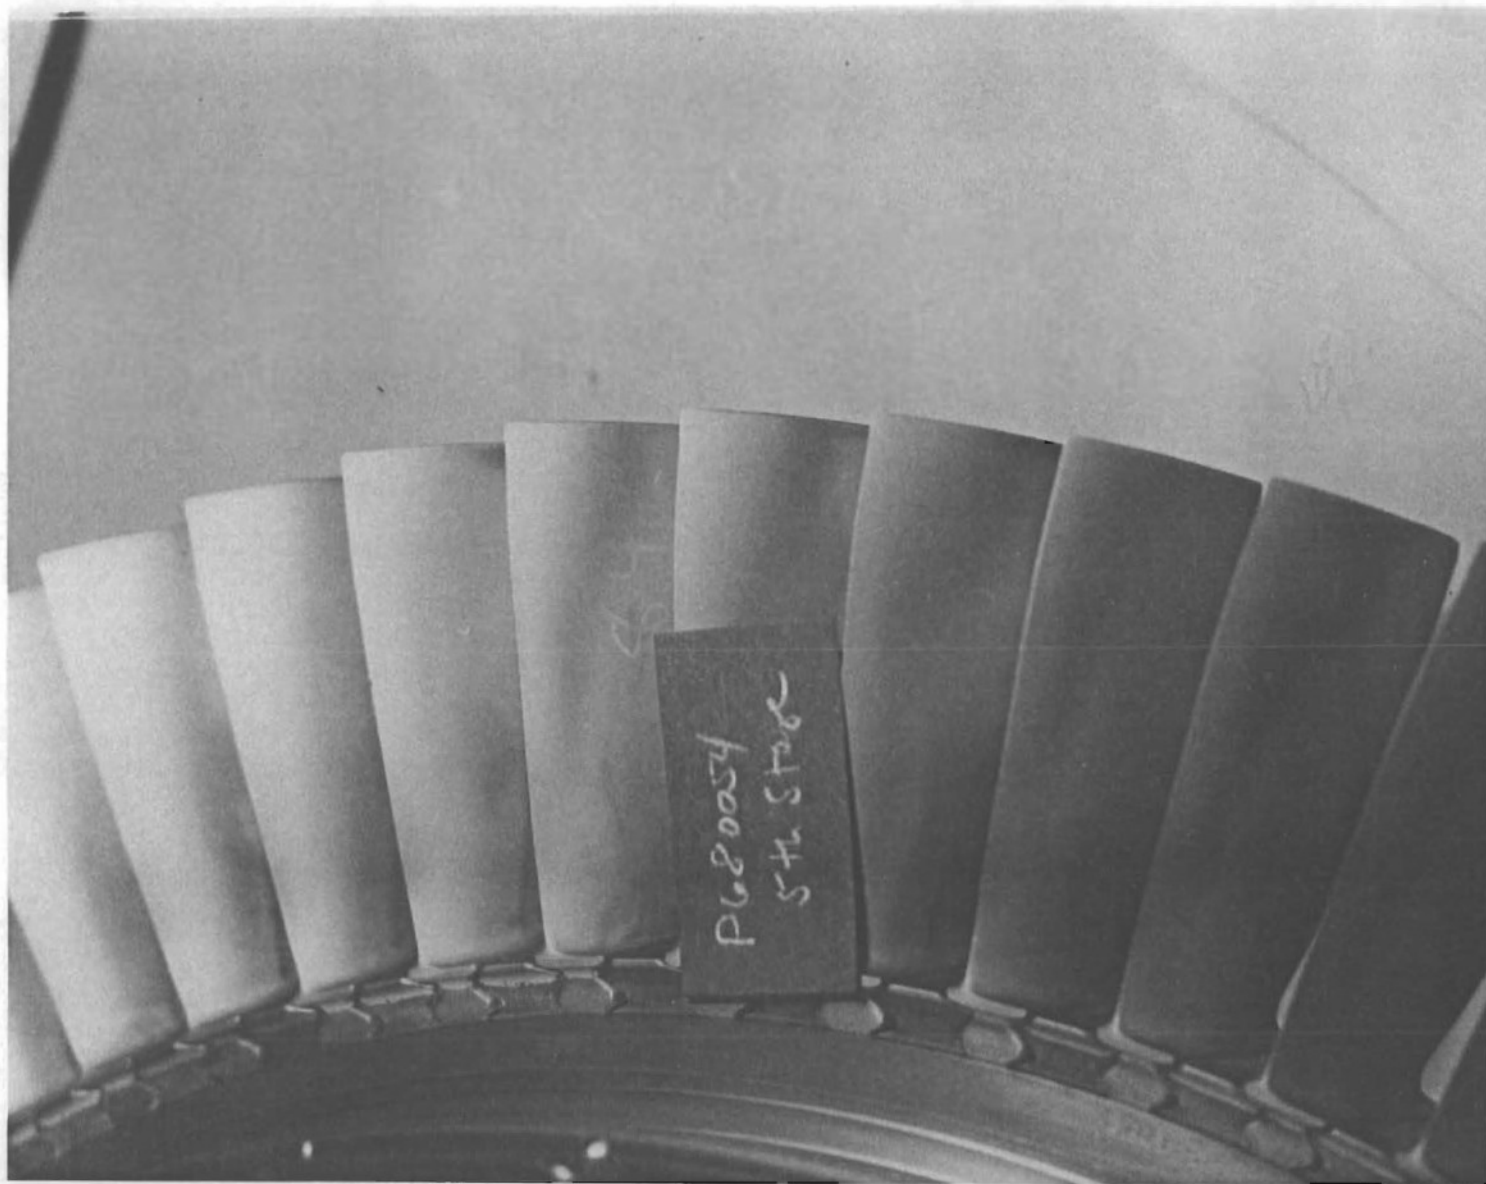
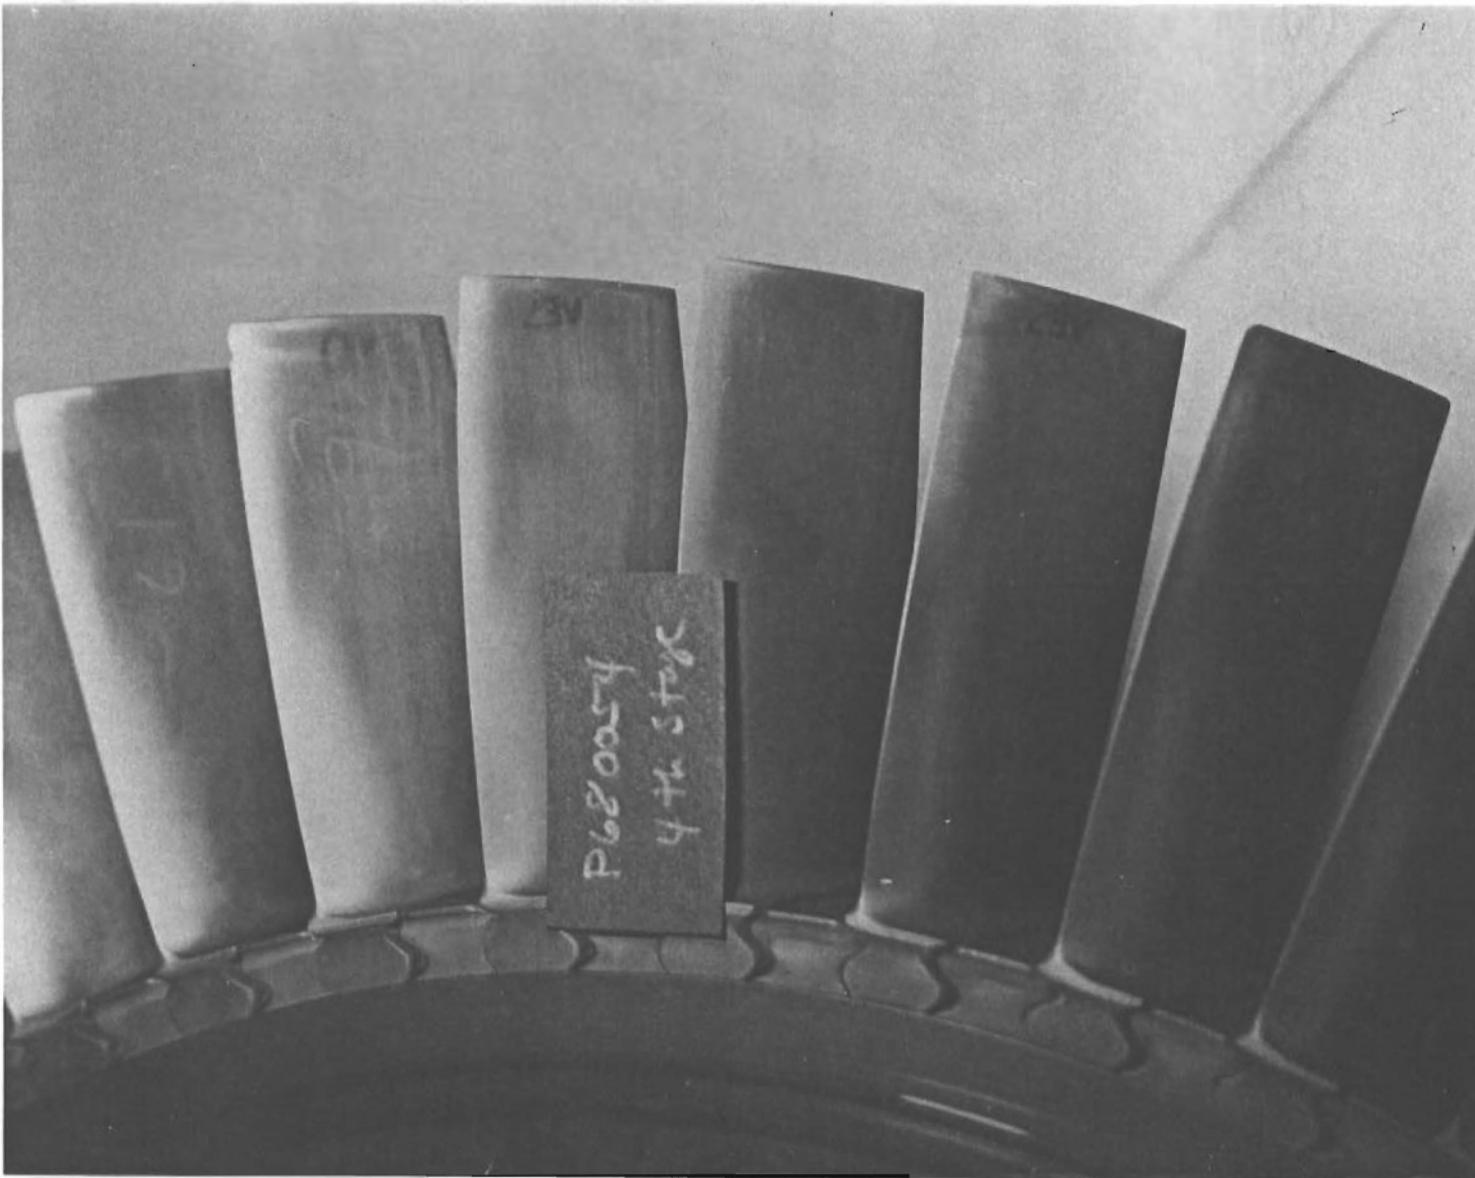
Figures 30 through 33 are photographs of the 7th, 6th, 5th and 4th stages of the high-pressure compressor, respectively. Some polishing and a small amount of material removal can be seen on the leading edge near the top. The tip region of these blades all appear to be in excellent shape. In addition, the abradable seals for these stages were also in excellent shape.
